NL INDUSTRIES/TARACORP SUPERFUND SITE GROUP
Leed Environmental, Inc.
Van Reed Office Plaza
2209 Quarry Drive, Suite C-35
Reading, PA 19609
Telephone: (610) 670-7310
Facsimile: (610) 670-7311

Re: NL Industries/Taracorp Superfund Site; Granite City, Illinois
Second 2016 Semi-Annual Operation and Maintenance Inspection (November 2016)

**NL Industries/Taracorp Superfund Site
Inspection Log - Operation and Maintenance**

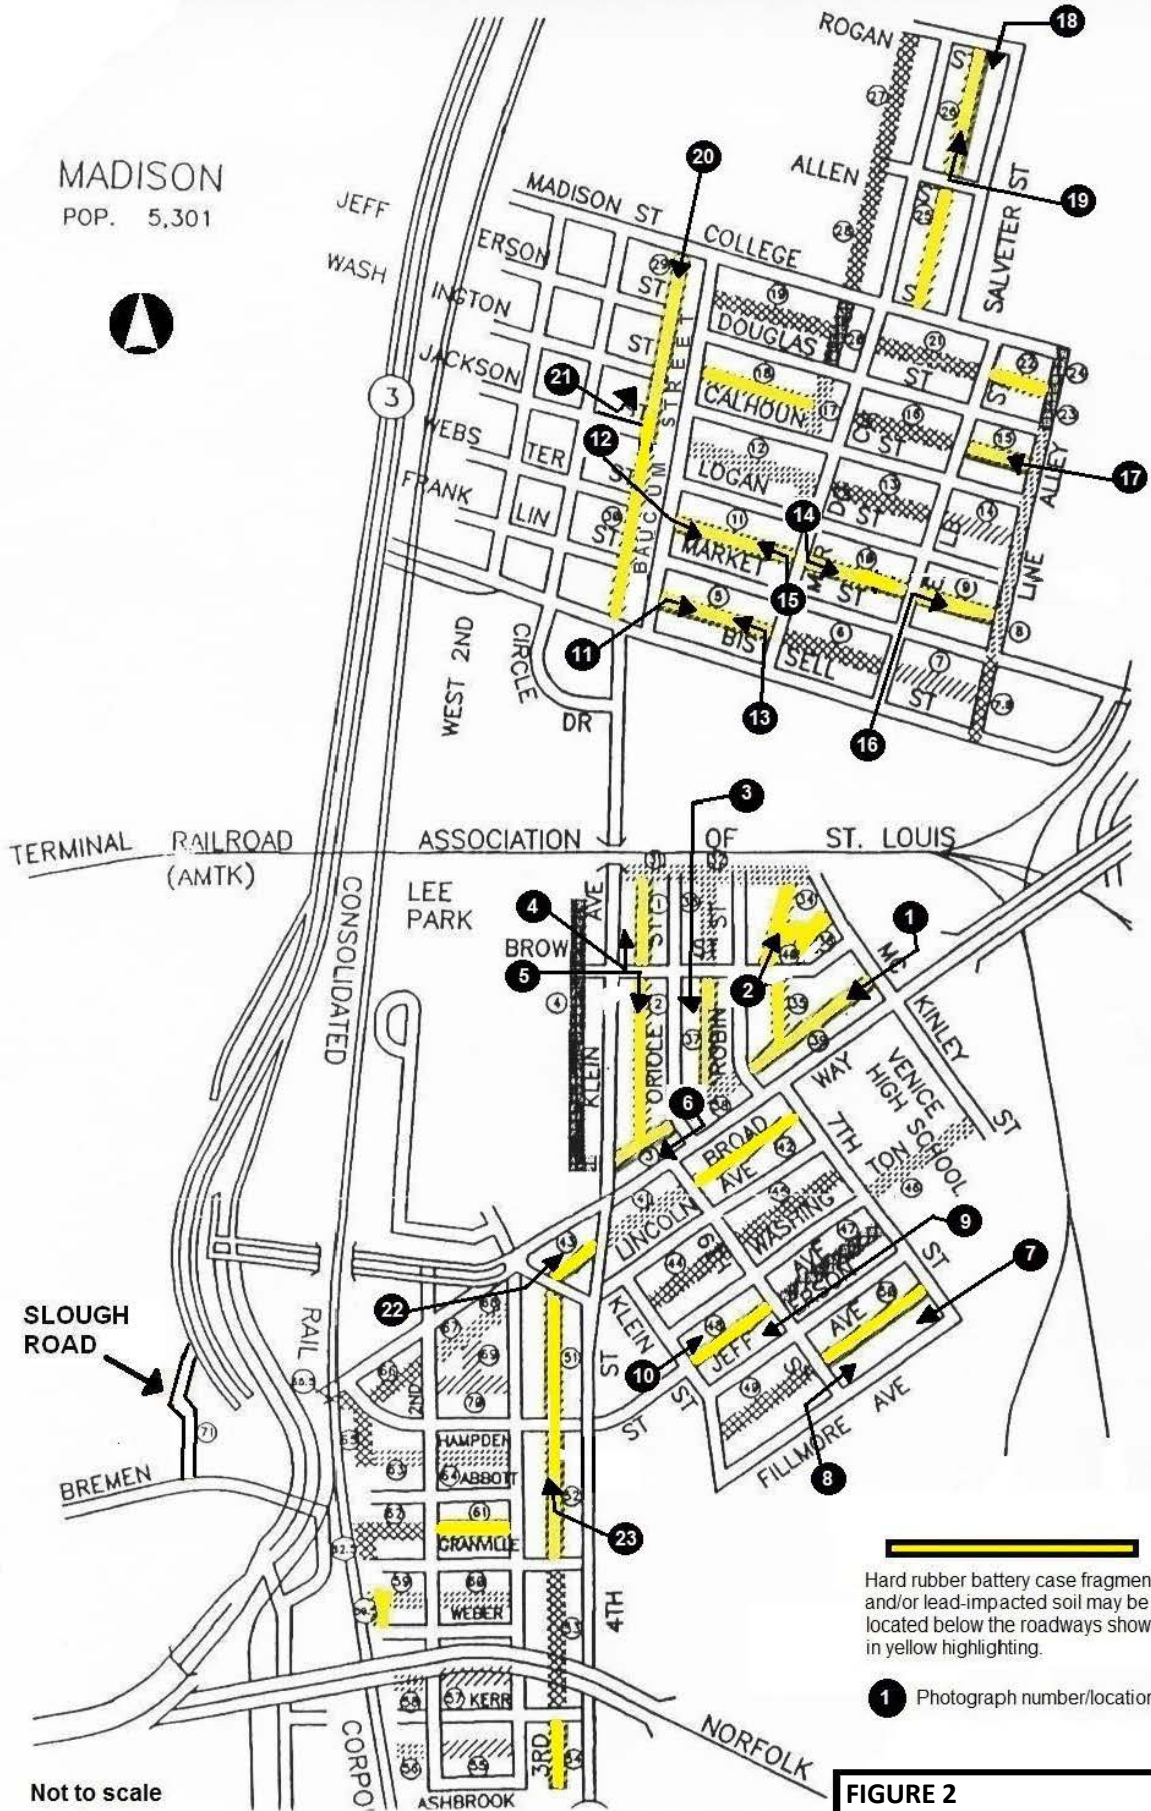
FIGURE 2
Venice Identified Roadways

- Alleys in Venice that were paved during remedial activities were inspected and noted to be in generally good condition, with some minor cracking and deterioration observed in some areas, with no battery case chips visible. The Venice alleys are shown on Figure 2 and are identified on the photographs in Attachment 4. Recent asphalt patching at the end of the alley along 6th Street (Attachment 4, photograph 9) confirms that the local municipality is continuing to repair and repave alleys, as necessary.

- Alleys in Venice that were paved during remedial activities were inspected and noted to be in generally good condition with some minor cracking and deterioration observed in some areas. The Venice alleys are shown on Figure 2 and are identified on the photographs in Attachment 4. Repairs were recently made to one of the alleys along 6th Street (Attachment 4, photograph 9).

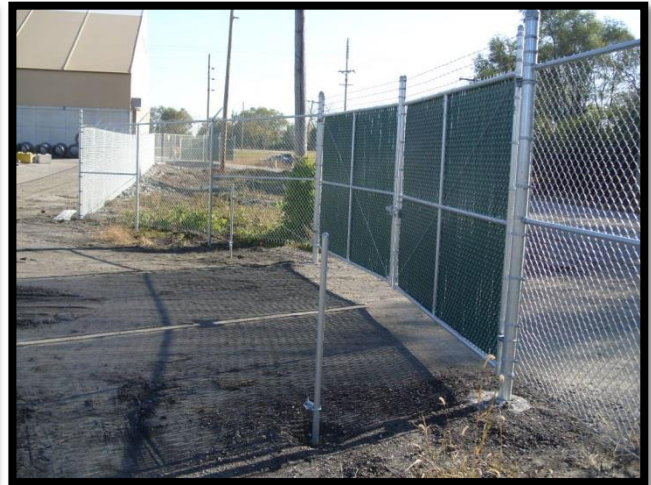
- Also regarding Slough Road, and as shown in Attachment 1 (photographs 1, 2, and 13-16), Beelman has recently installed perimeter security fence around its warehouse building. The perimeter security fence extends along Bremen Street on the south end of the Slough Road area. The fence and locked gate along Bremen Street restrict access to Slough Road; access to Slough Road is no longer possible without passing through the Beelman office and security area along Route 3.

Photograph 2: Slough Road, inside of gate/fence along Bremen Street.

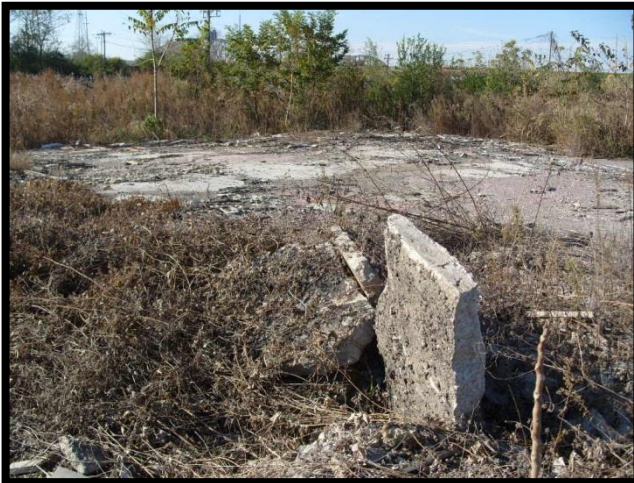
Photograph 5: Slough Road, concrete debris, foundation of former Robin's Nest Lounge.

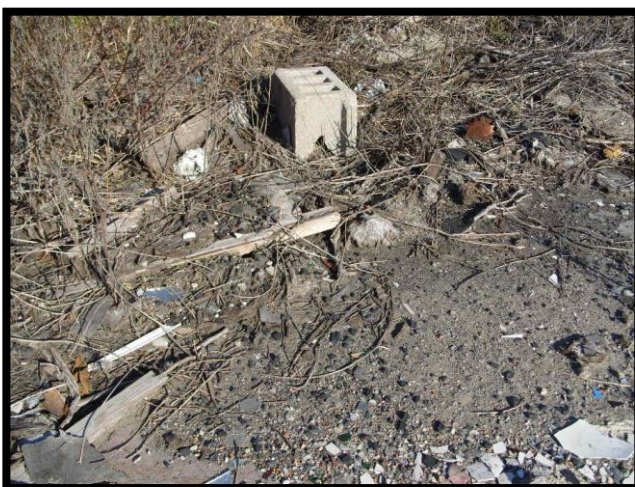
Photograph 8: Slough Road, small area of battery case chips along building foundation.

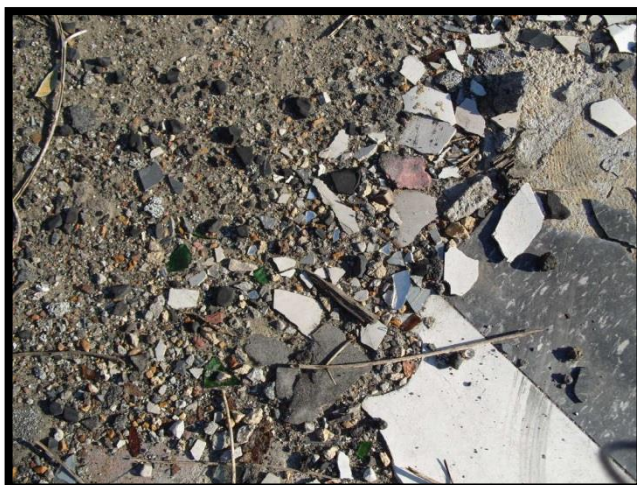
Photograph 9: Slough Road, small area of battery case chips along building foundation.

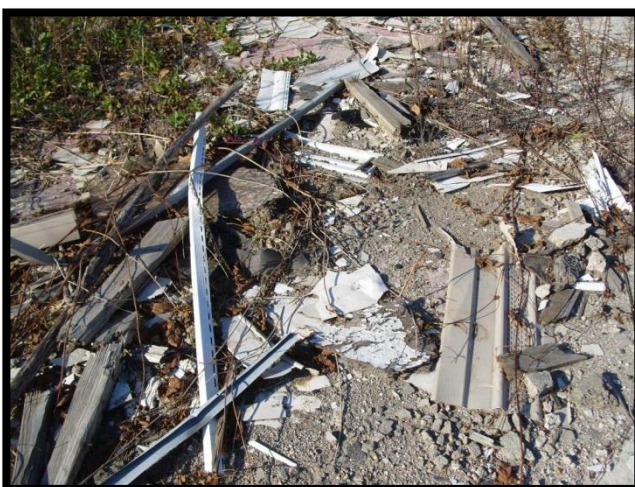
Photograph 12: Slough Road, building demolition debris on concrete foundation.

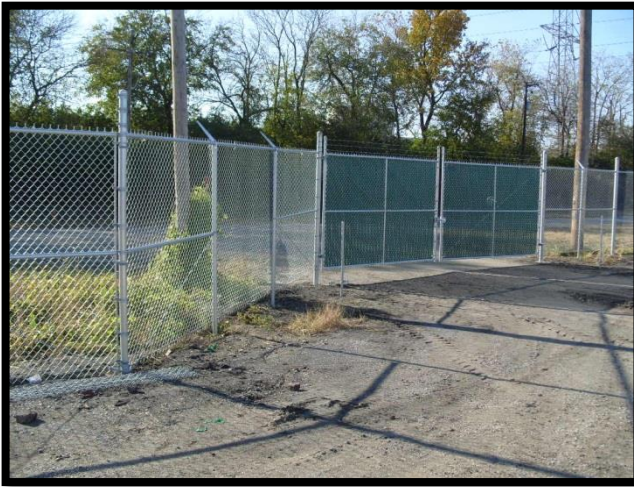
Photograph 13: Slough Road, inside of fence, gate along Bremen Street.

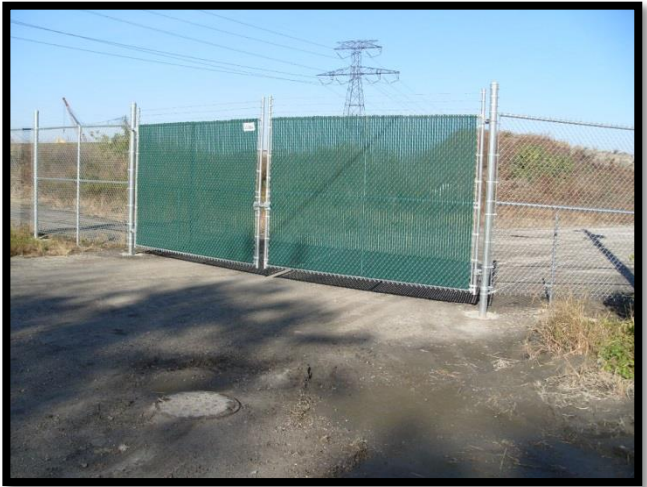
Photograph 14: Slough Road, outside of gate along Bremen Street.

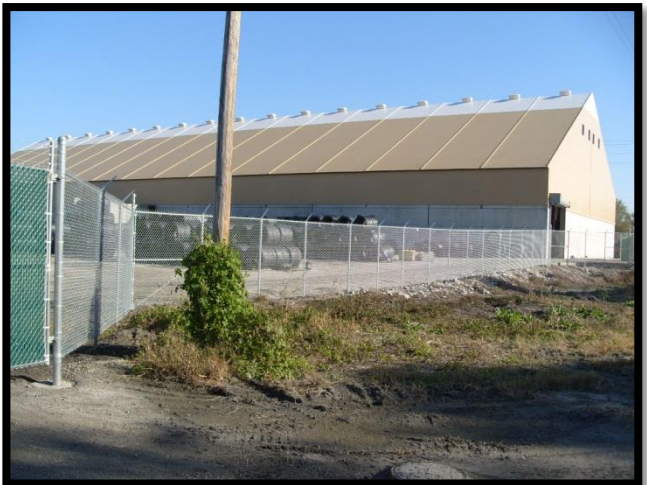
Photograph 16: Slough Road, fence along south side of property.

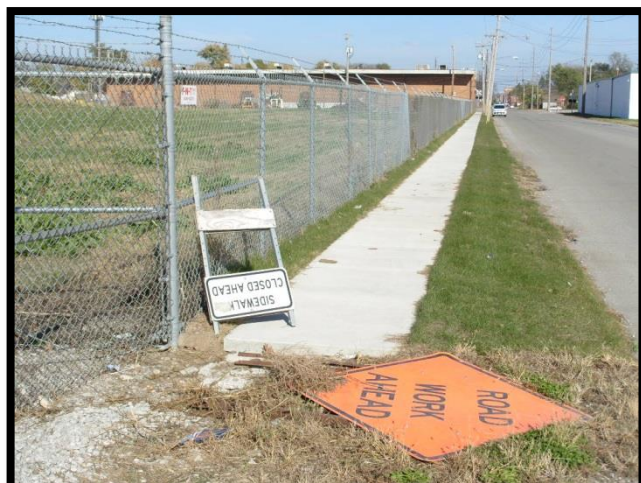
Photograph 57: Southern end of concrete sidewalk on 1555 State Street property (adjacent to former Rich Oil property).

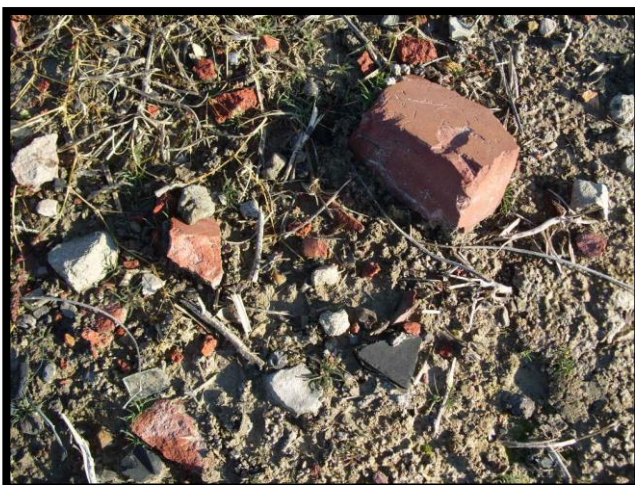
- Remote fill properties (Schaeffer Road and Sand Road) previously remediated by EPA (and where lead-impacted soil and/or battery case chips may remain in place at a depth of three feet below ground surface) were observed during the inspection. Photographs are provided in Attachment 6 and Attachment 7, respectively. There was no evidence of disturbance at Schaeffer Road. At Sand Road, most of the scattered hard rubber battery case chips and some other debris (bricks, etc.) are evident near the foundation of the former building.

Photograph 10: Battery case chips on soil surface near former concrete foundation.

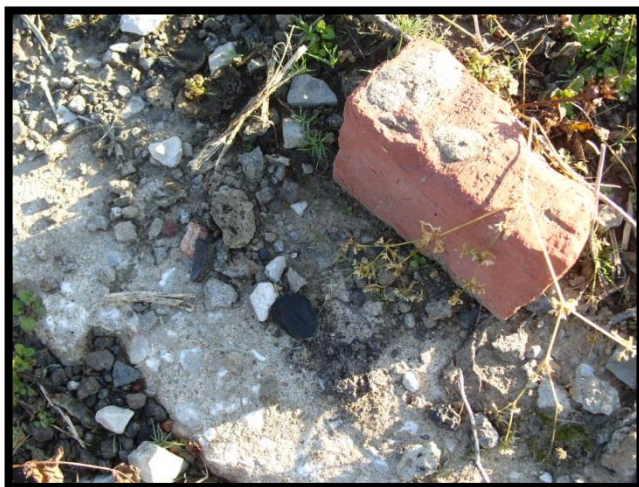
Photograph 11: Battery case chips, bricks, and debris on soil surface near former concrete foundation.
